**PRELIMINARY INITIAL SITE ASSESSMENT**

**Sunset Road: Silverbell Road to I-10 Eastbound  
Frontage Road – Segment 1  
Tucson, Pima County, Arizona**

**EEC PROJECT NO. 13039  
REPORT DATE: September 23, 2014  
REVISED: November 5, 2014**

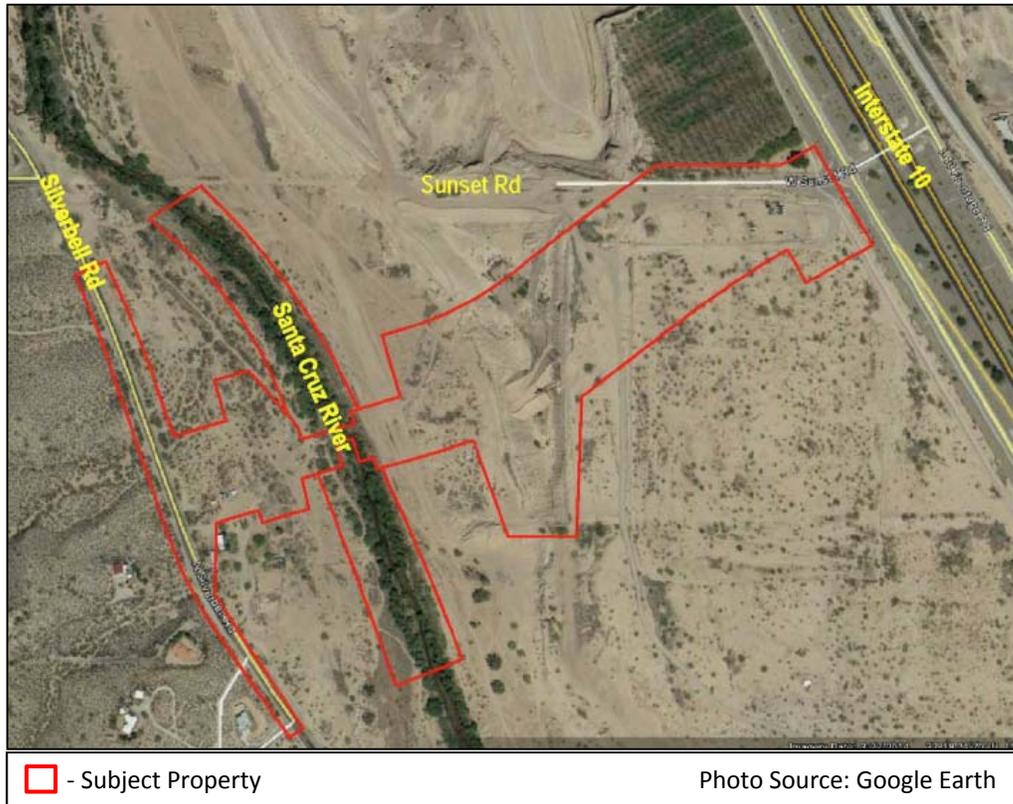
Engineering and Environmental Consultants Inc. (EEC) completed a Preliminary Initial Site Assessment (PISA) for the Sunset Rd. Project located between Interstate 10 (I-10) and Silverbell Rd., Tucson, Pima County, Arizona (Project Area) as shown in the aerial below.

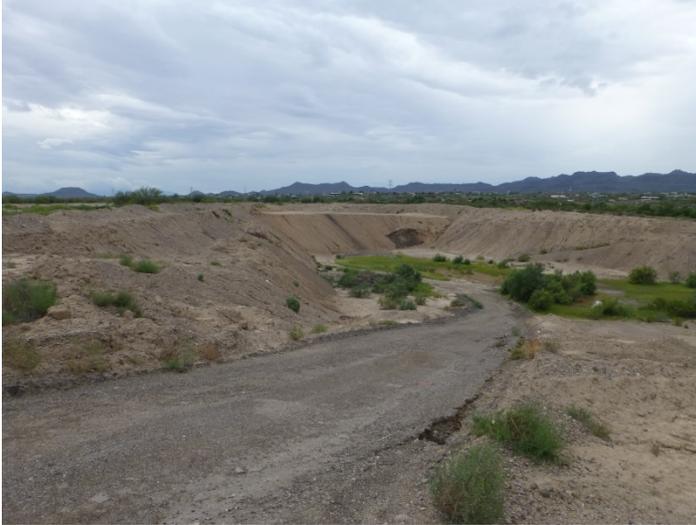
**Photo No. 1**

**Description:** Gravel pit

**View:** South

- Observed:
- A gravel pit is located within the project area. EEC assumes no debris has been deposited during infill activities and has no evidence to suggest otherwise. However, illegal dumping generally consisting of used tires and debris was noted in the project area and along the Santa Cruz River. See comments.
  - High voltage power lines run along the west side of the Santa Cruz River.
  - At least two TEP pole-mounted transformers were observed along Sunset Rd. and two TEP transformers (one pole-mounted, one pad-mounted) were observed along Silverbell Rd. See comments.
  - One water well was observed near the residential structures located along the southeast portion of Silverbell Rd. The well did not appear to be active. This well was not located during a search of the ADWR Well Registry Map or the ADWR Well Registry Report. See comments.
-

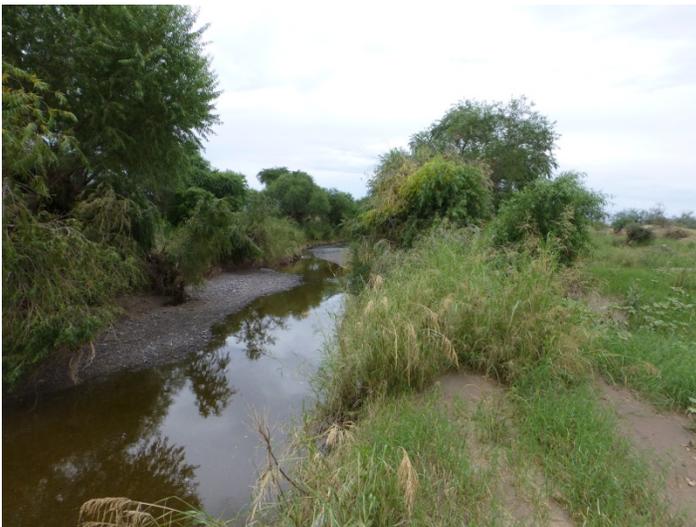
**Photo No. 2**

**Description:** Santa Cruz River

**View:** North

- Miscellaneous dumping was observed in the Project Area and along the Santa Cruz River and generally consisted of some used tires, landscape debris, wood, and green waste. The dumping does not warrant further investigation, however the material should be removed and properly disposed.

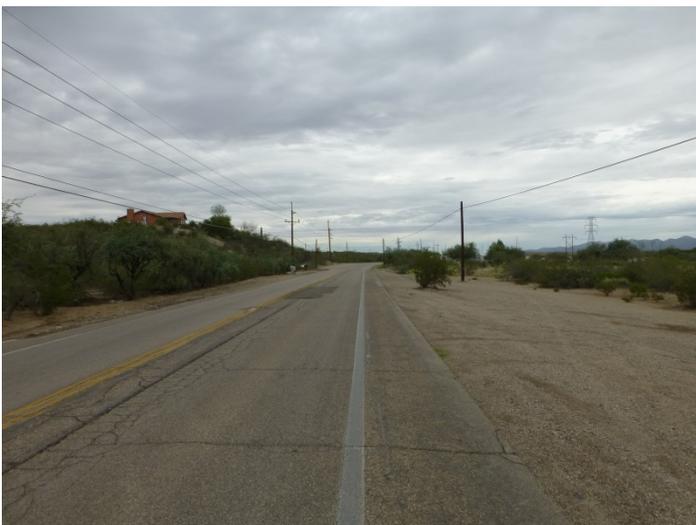
**Photo No. 3**

**Description:** South portion of  
Silverbell Rd.

**View:** North

- One water well was observed near the residential structures located along the southeast portion of Silverbell Rd. during the time of the site visit. This well was not located during a search of the ADWR Well Registry Map or Report and appears to be located within the project area. EEC recommends caution during earth disturbance activities and the registry to be notified should transfer of ownership occur.

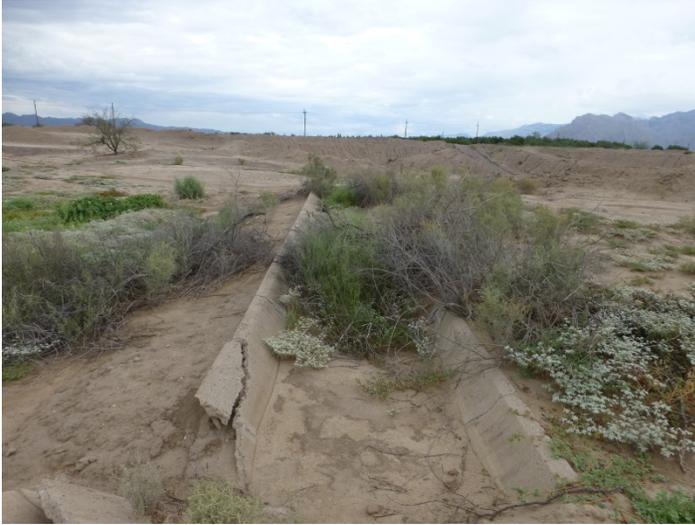
**Photo No. 4**

**Description:** Former irrigation canal within project area

**View:** Southeast

- A concrete channel and debris was observed on the subject property during the time of the site visit. EEC recommends the debris be removed and properly recycled/disposed of prior to earth disturbance activities.

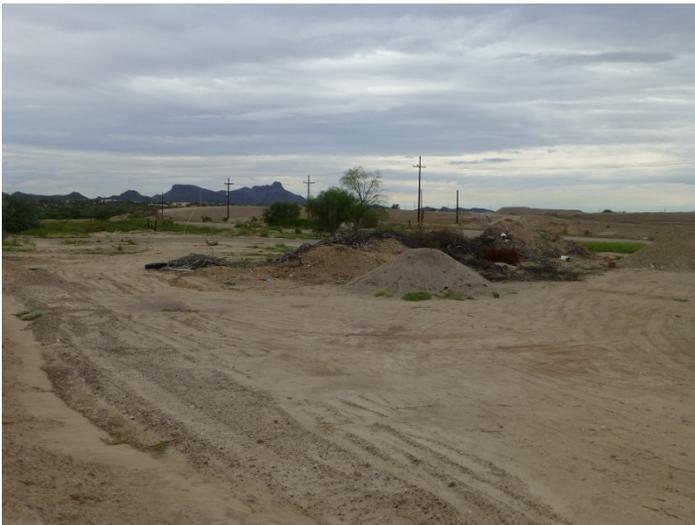
**Photo No. 5**

**Description:** Miscellaneous soil/green waste within project area

**View:** Northeast

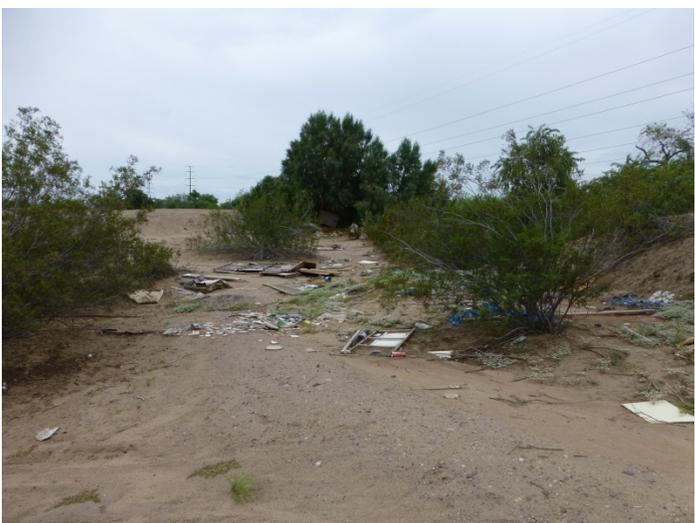
**Photo No. 6**

**Description:** Miscellaneous debris within project area

- A concrete channel and debris was observed on the subject property during the time of the site visit. EEC recommends the debris be removed and properly recycled/disposed of prior to earth disturbance activities. No further action is recommended.
- Miscellaneous dumping was observed in the project area and along the Santa Cruz River and generally consisted of some used tires, landscape debris, wood, and green waste. The dumping does not warrant further investigation, however the material should be removed and properly disposed
