YOUR LIVING RIVER

CHANGES ALONG THE LOWER SANTA CRUZ RIVER - 2013 TO 2015

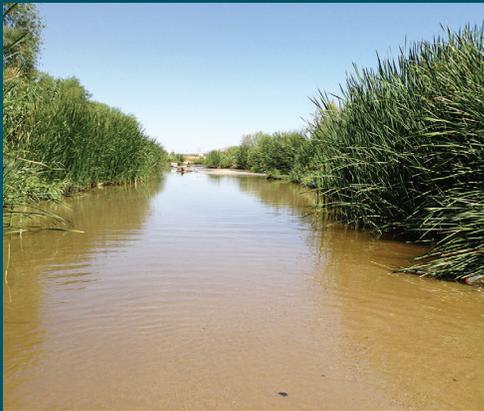
Cloudy water, before upgrade

- **Water clarity much improved:** Sediments and other particles carried in the water decreased, resulting in clear river water on normal non-flooding days. Elevated levels of materials in the water can increase water temperature, thereby decreasing available dissolved oxygen.

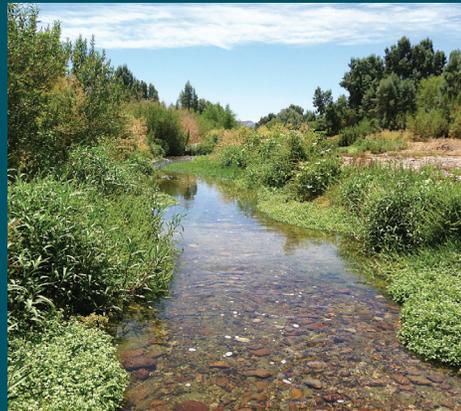
Clear water, after upgrade
